SUPERIOR SEWER CO.

## SEWER INSPECTION

10/09/2025

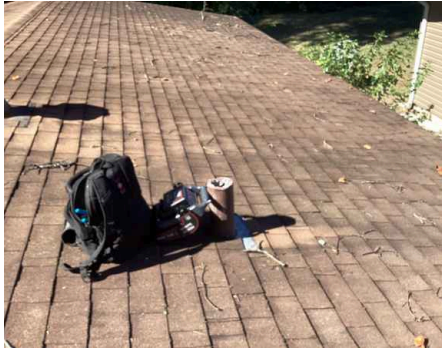
#### Drain System: Sewer Lateral Access Location/s

Roof

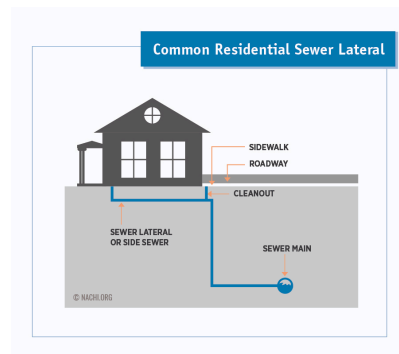
#### Drain System: Sewer Lateral Material

Cast Iron, Clay

All sewer line materials are not always identifiable.

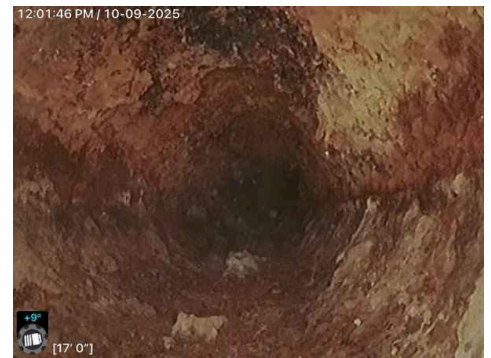
#### 2.1.1 Drain System

##### **CORROSION / SCALING**

There is cast iron build up altering the diameter of the sewer lateral line. This prevents proper flow, and increases the likelihood of a future blockage. In addition to the loss in diameter, scale build up can be hiding cracks and or breaks. We cannot comment on the structural integrity of the pipe beyond / behind the scale build up. We recommend descaling and re-camera by Superior Sewer Company.

Contact a qualified professional.

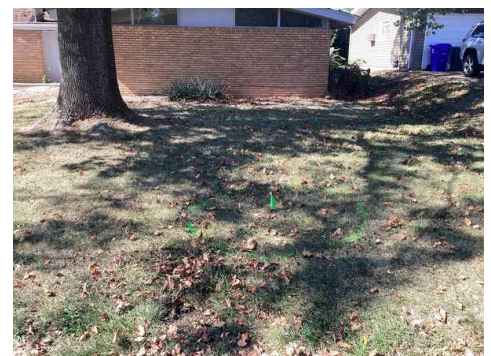
#### 2.1.2 Drain System

##### **INSTALL YARD VENT - UNABLE TO REACH MAIN**

Depth -10'

No yard vent was identified during the inspection. Due to the length and/or the amount of bends in the line, our camera runs out of reel or push leverage. It is recommended that yard vents are installed at least every 100ft for access to the sewer lateral line. We cannot comment on the structural integrity of the pipe beyond this location.

Contact a qualified professional.

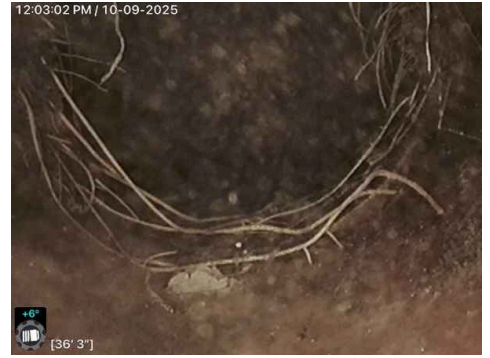
2.1.3 Drain System

**ROOT GROWTH - CLAY LINE (ANNUAL MAINTANCE RECOMMENDED)**

The sewer lateral line will require scheduled maintenance, ensuring proper flow and function. This typically is due to light root growth in clay sections of the lateral line. Recommending a camera one year from now to re-assess root growth to determine if the line will need scheduled cleaning. No immediate service is recommended at this time.

Contact a qualified professional.
